# BACKUP INFORMATION

**STS-108  
IN-FLIGHT ANOMALIES  
BACKUP**

<b>STS-108-V-01 and 02: RCS THRUSTERS R4U AND F3F FAILED OFF</b>	Presenter:
	Organization/Date: Orbiter/02-14-02

**STS-108 IMU-2 Z-AXIS/REDUNDANT  
RATE ANOMALY**

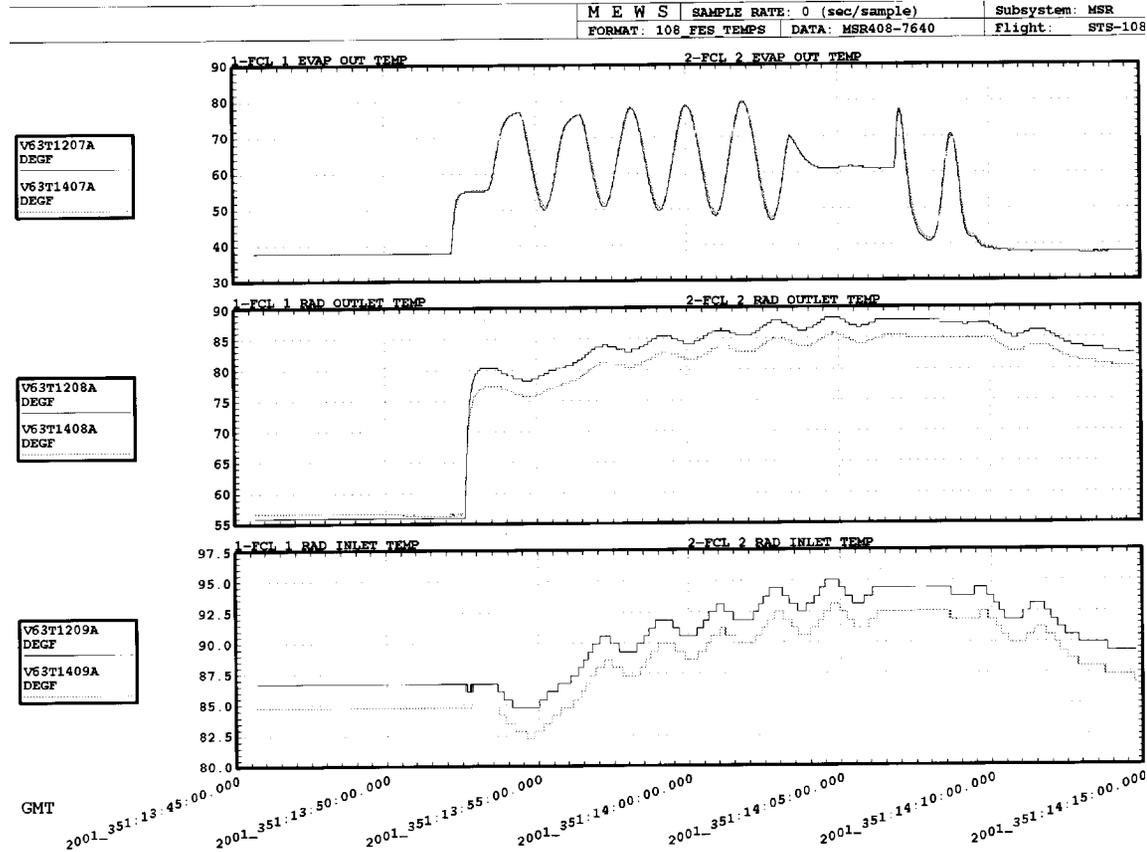
- The FES failed to control the outlet temperature during on-orbit check-out of the FES secondary controller

- Post-flight troubleshooting of OV-105 FES isolated the secondary mid-point temperature sensor as the cause of the STS-108 anomaly
  - Controller functional test performed with nominal results
  - Steady state reading of the sensor was within 0.25°F of the two primary sensors
  - However, transient (ramp) test showed a 2-second lag
    - Previous experience indicates loss of thermal conductivity of packing
  - Sensor R&R is planned for February 12th, to be completed by end of week
- Newly refurbished FES is installed in OV-102 at OMM
  - Successfully passed ATP testing
    - All controllers & control modes verified in ATP
  - OMRSD test complete with no open issues

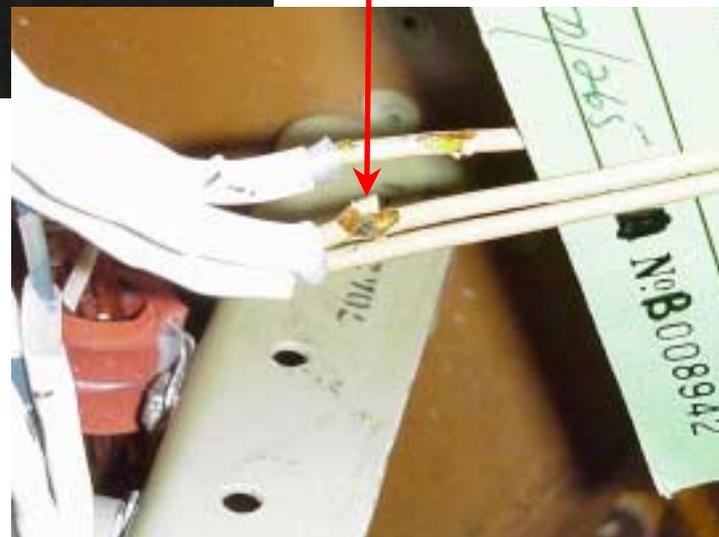
CONDUCTOR DAMAGE

- Damage pattern in the aft confirms that more damage is induced in higher-traffic areas
  - Higher number of PRs found in higher traffic areas
- Significant damage groupings in the aft were inspected and repaired on other vehicles
  - Exposed conductors between the ends of convoluted tubing and clamps or connectors
  - Exposed conductors in the backshells of the monoball connectors
  - Exposed conductors near connector backshells

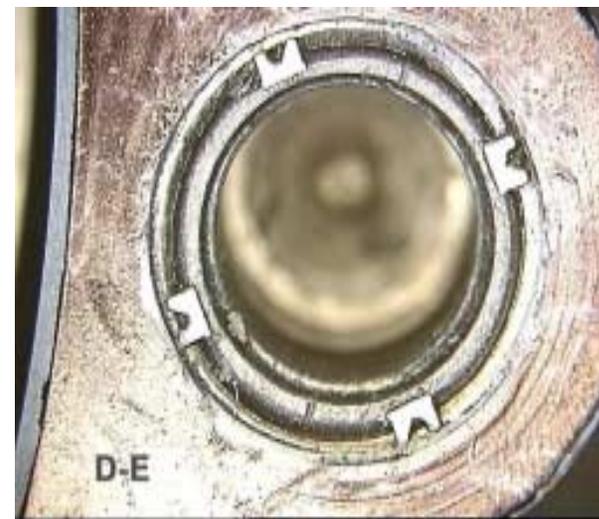
INSTALLED INSERT

STRIPPED HOLE WITH KEY MATERIAL
